## **TEST & EVALUATION REPORT**

Screening Evaluation of Shingle Rejuvenator

Report For: BioBased Spray Systems

Client: BioBased Spray Systems Project No.: BBSS 01-02-01

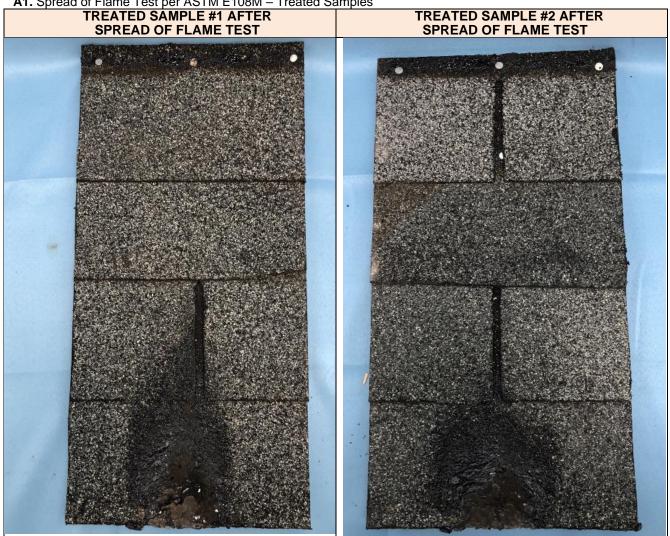
A1. Spread of Flame Test per ASTM E108M – Treated Samples

Spread of flame covered less surface area (a distinct benefit). This is worthy of further investigation.

- 1. Flexibility<sub>23°C</sub> was improved (Failure to pass).
- 2. Granular Adhesion was improved significantly from a granular loss of 1.11 g to a loss after treatment of 0.15 g, an 86% improvement.
- 3. Hail Impact was slightly improved after treatment. The improvement, 6.6%, was minimized by the type of shingle evaluated organic felt based. The data suggests Hail Impact would have a greater improvement on FG mat-based shingles.
- 4. Fire Resistance 'UL Speed of Flame:' The treated shingles exhibited a flame spread of 86 in² vs. the untreated shingles exhibiting a 144 in² spread. This was unexpected.

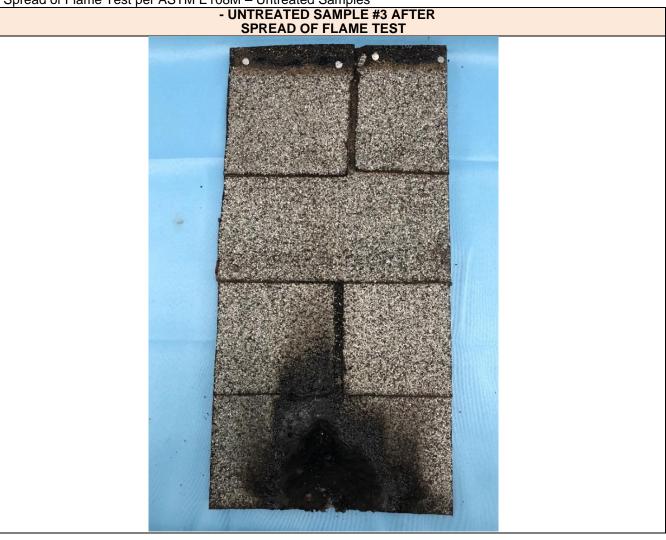
A2. Spread of Flame Test per ASTM E108M – Untreated Samples

The control exhibited significantly more spread and damage than the treated shingles.

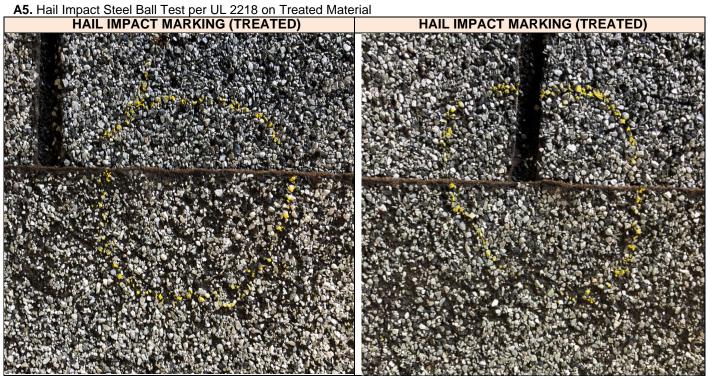
Because the test shingles were organic felt based, the criteria for Hail Impact Resistance; cracking, and damage to the shingle surface was not observed.

Consequently, we included photos exhibiting the results on the granular surface. The results were mixed primarily due to the severely aged conditions of the test shingles. However, the treatment appeared to re-adhere the granules, which reduced the surface damage some.
